Safety Inspection Report

Annual Inspection

Hyde Road

Long Sutton & Well Parish Council

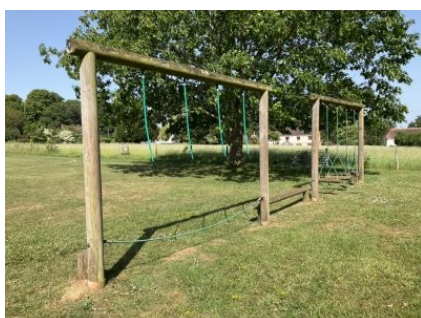
This equipment relies on one post for its stability. Special attention should be paid to maintenance (e.g. by monitoring degradation) and if necessary decommissioning the item before the end of its operating life. This is a requirement of the British Standard.

Consult with the manufacturer's guidance to determine suitable maintenance.

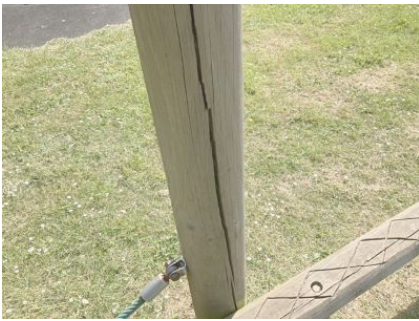
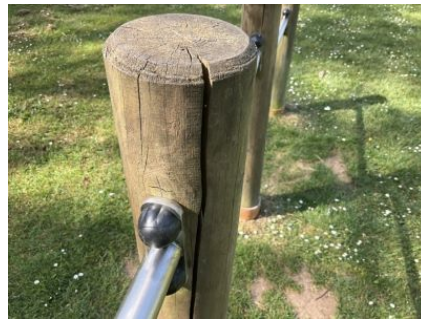
There are natural splits / shakes in the timbers.

Monitor and sand back any splintered edges as required.

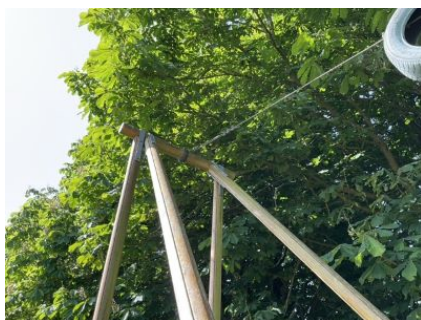
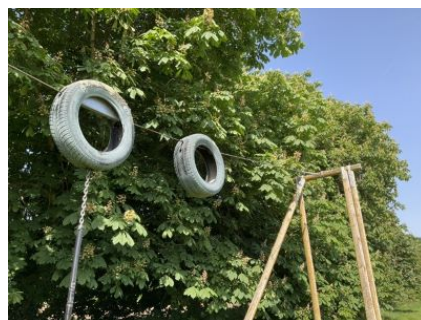
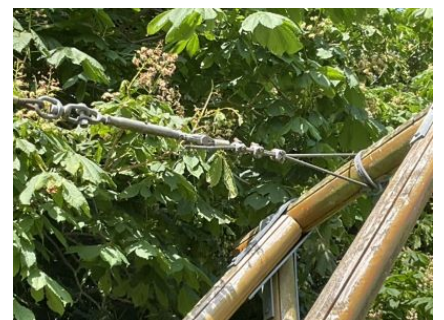
The supporting components should be dismantled and inspected according to the manufacturer's instructions. This will need doing on a regular basis, as defined by the manufacturer. This can lead to a high risk if no action is taken.

Dismantle and inspect according to manufacturer's instructions.

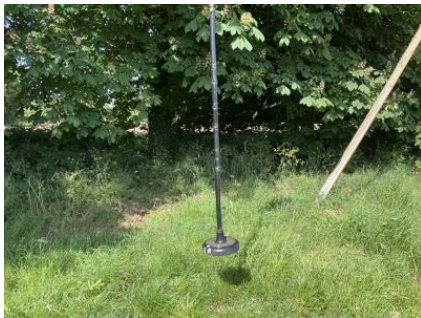
Chain covers prevent a thorough inspection of all chain links.

Remove chain covers to inspect according to manufacturer's instructions.

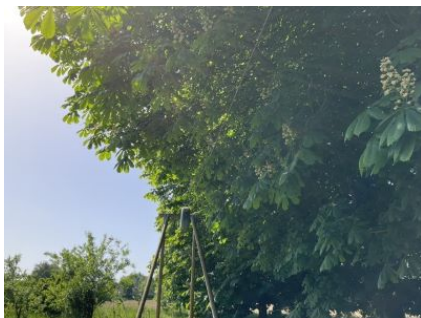
Overhanging tree branches are present.

Cut back.

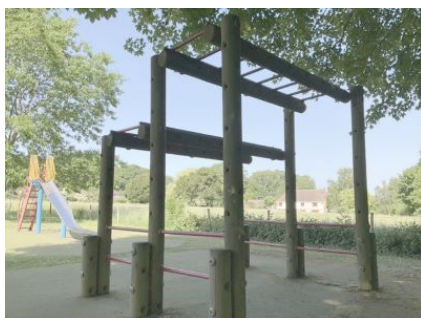
Overhead ladders and rings provide significant play value and benefits to children, and with it the risk of falling. Ensuring the surface remains in good condition will help to keep the correct balance between benefits and risk.

The protective surface under all bars and rings must be kept in good condition.

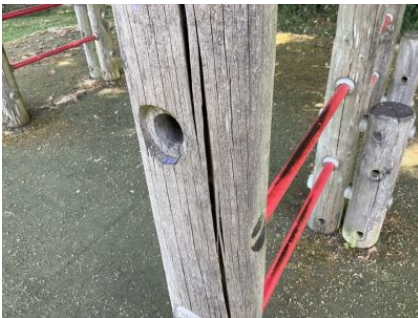
There are natural splits / shakes in the timbers.

Monitor and sand back any splintered edges as required.

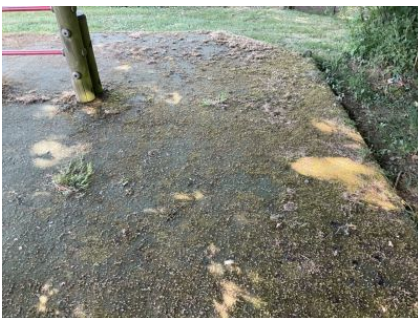
Surface has unintended grass, moss or weeds.

Remove.

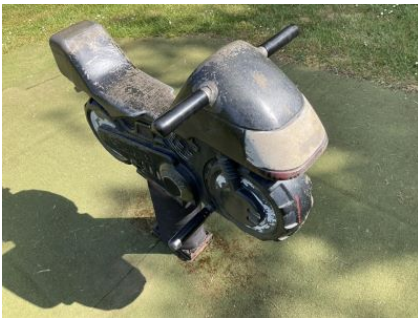
Protruding handles / foot rests.

The unit was installed prior to the publication of the current standards. There is no requirement to make retrospective changes.

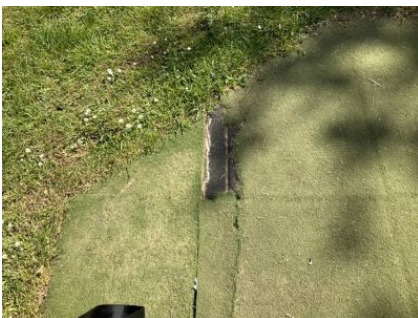
Surface needs repair.

Repair.

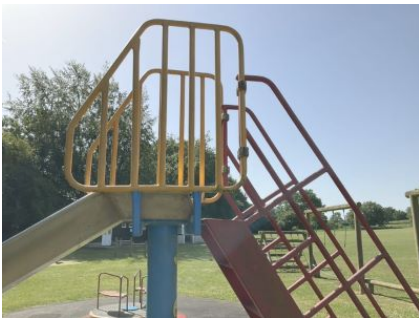
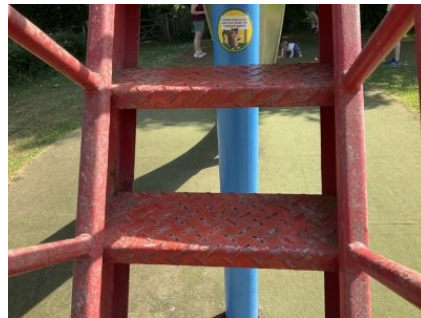
There is a head entrapment.

The unit was installed prior to the publication of the current standards. There is no requirement to make retrospective changes.

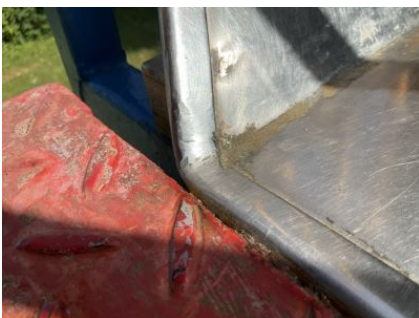
There is a toggle entrapment.

Read the notes for further action.

Monitor.

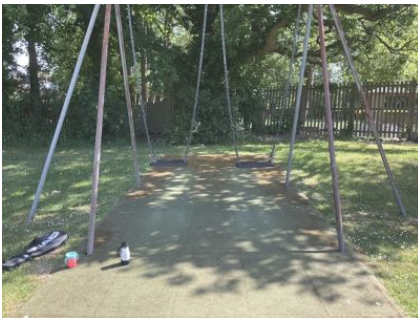
The distance between the seat side and the support is insufficient.

The unit was installed prior to the publication of the current standards. There is no requirement to make retrospective changes.

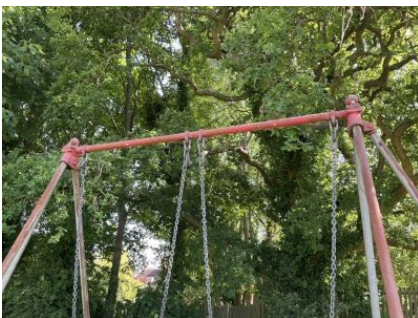
We are unable to gauge the structural integrity of this unit.

We advise an internal inspection of all parts or replacement.

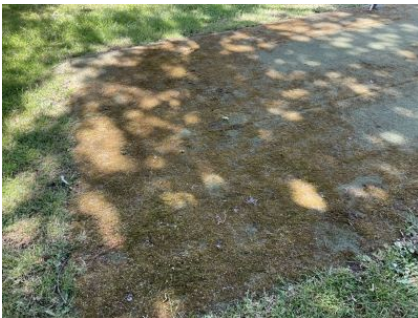
Moss is present.

Remove.

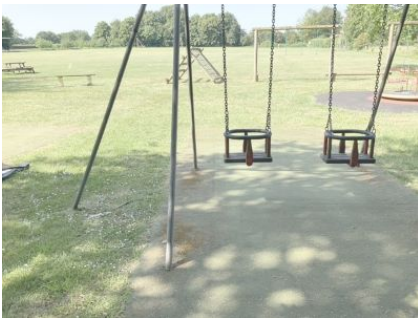
The distance between the seat side and the support is insufficient.

The unit was installed prior to the publication of the current standards. There is no requirement to make retrospective changes.

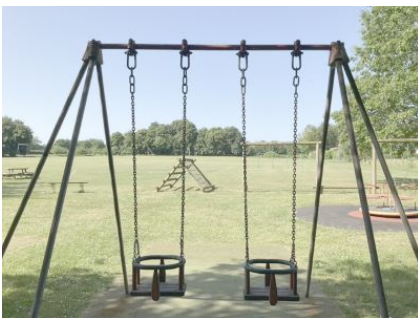
There is insufficient splay on the swing chains.

No reasonably practicable action is identified.

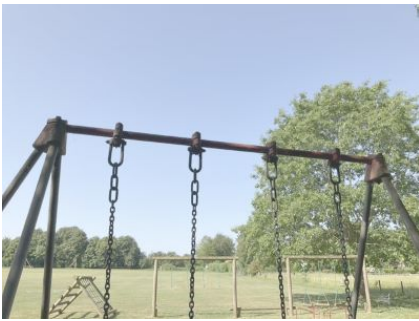
We are unable to gauge the structural integrity of this unit.

We advise an internal inspection of all parts or replacement.
